Mock Inspection Report

1916 Galt Commons, Kennesaw, GA, USA

Jan 17, 2025

This is a mock inspection report to demonstrate that the inspector has performed an inspection according to the [InterNACHI® Standards of Practice](#).

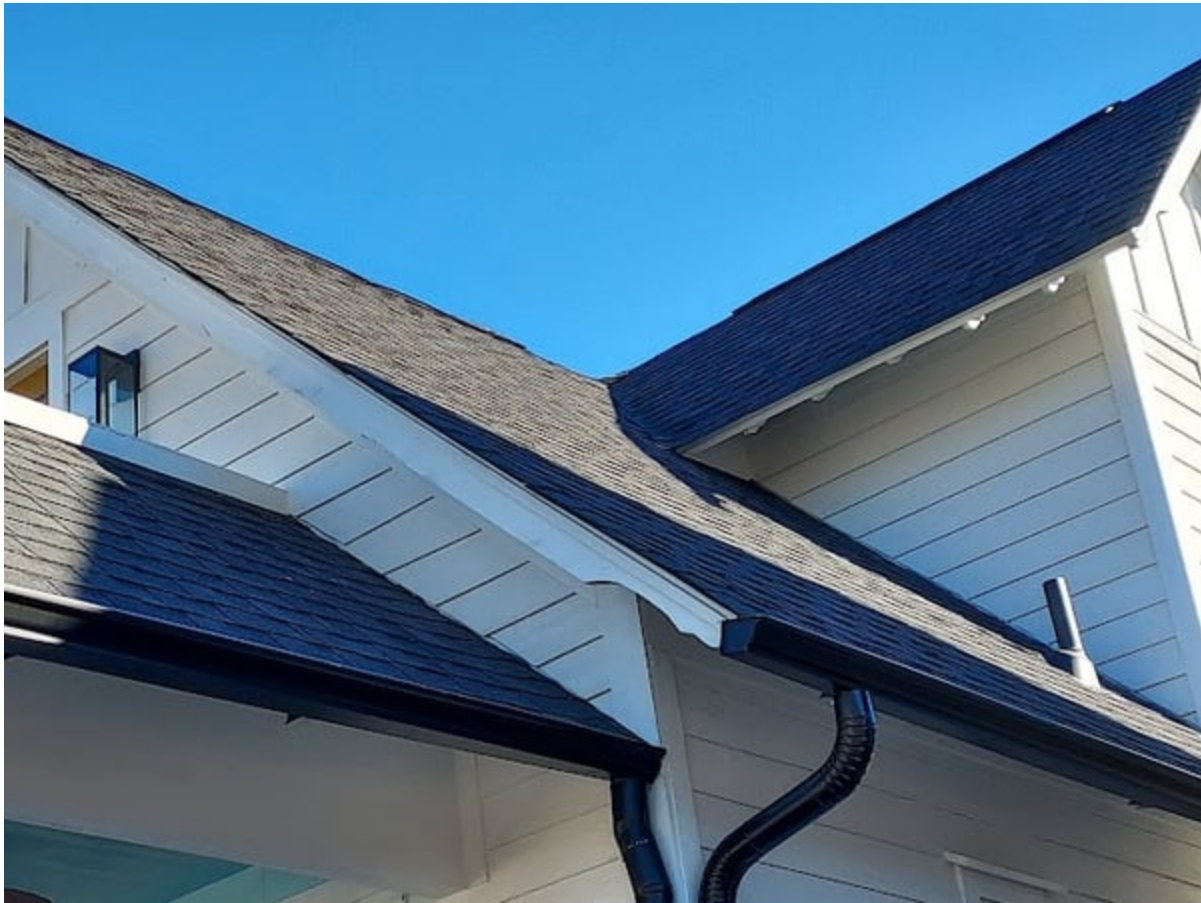
Roof-Covering Materials

Pitch is steep so I did a visual inspection from ground level. Roof structure and covering is fairly new. Asphalt shingles material.

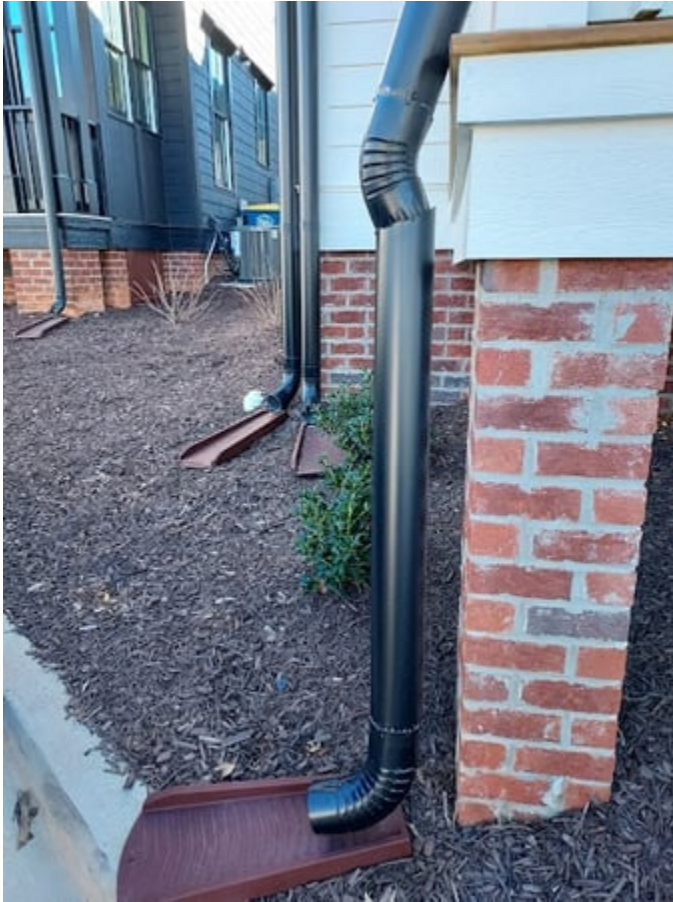
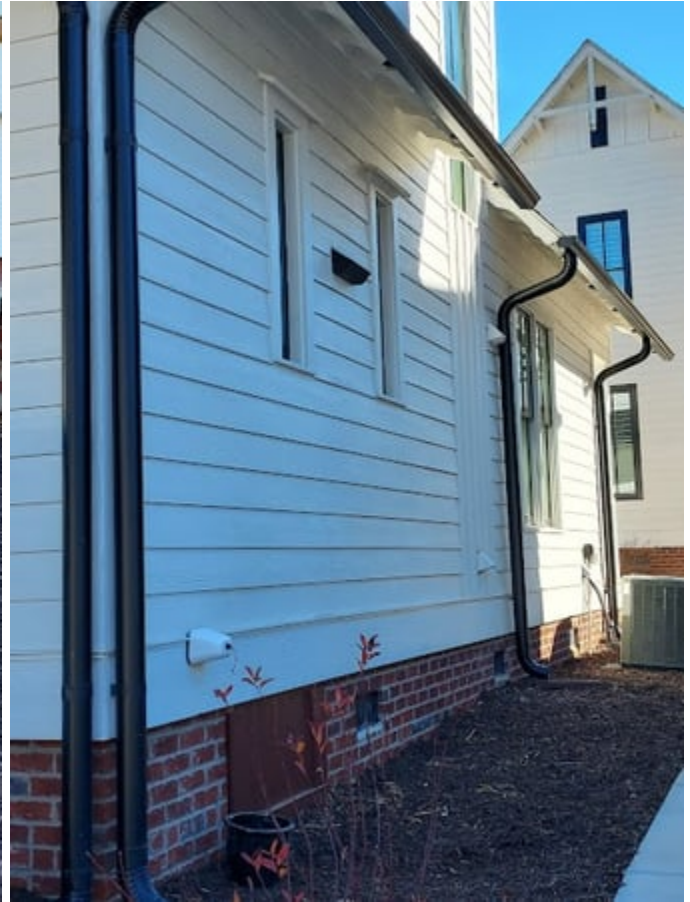
Downspouts

All downspouts were secure and splash blocks in place.

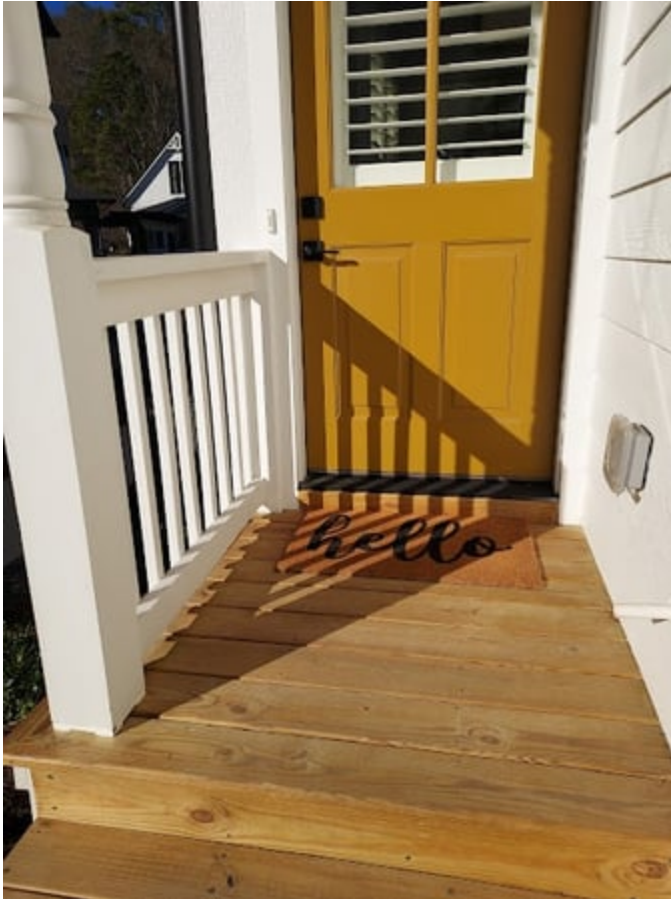
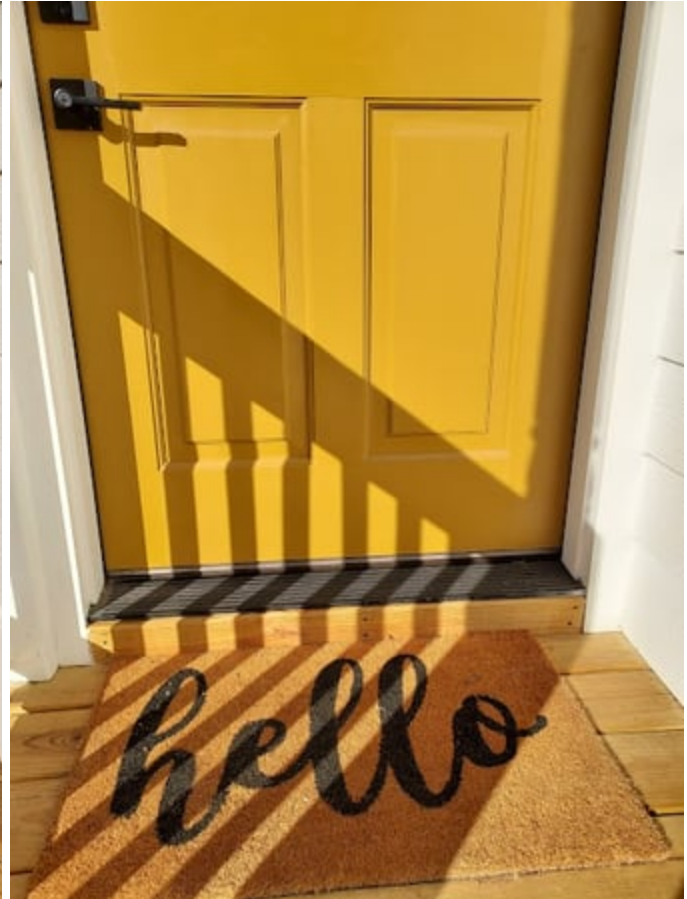
All Exterior Doors

Front entrance door and rear entrance door operated without issue. Weather stripping intact and in good shape. No defects around sill.

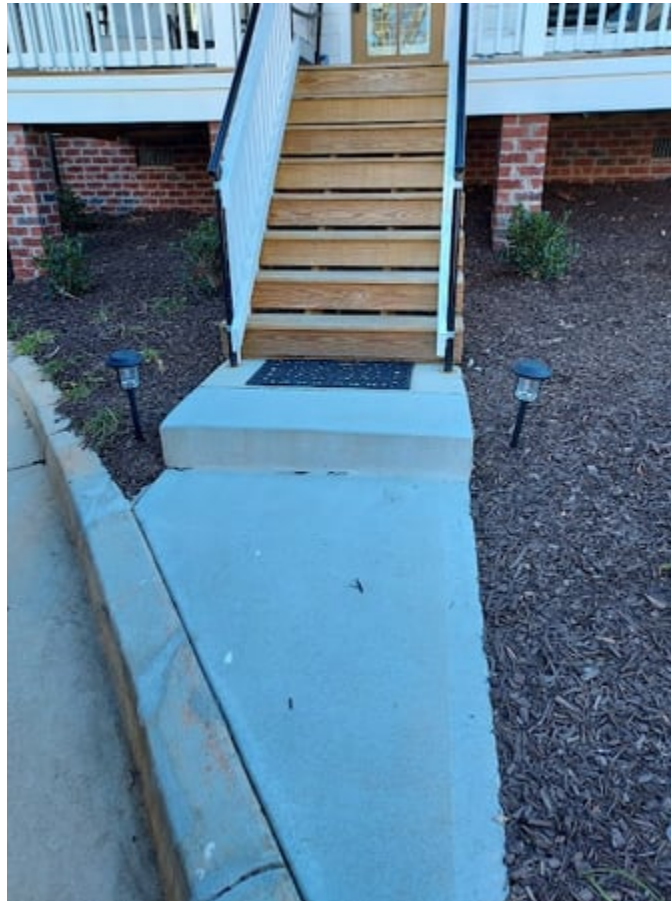
Adjacent Walkways and Driveways

Walkway is poured concrete. No cracks or noticeable damages. Street parking only, no driveway to inspect.

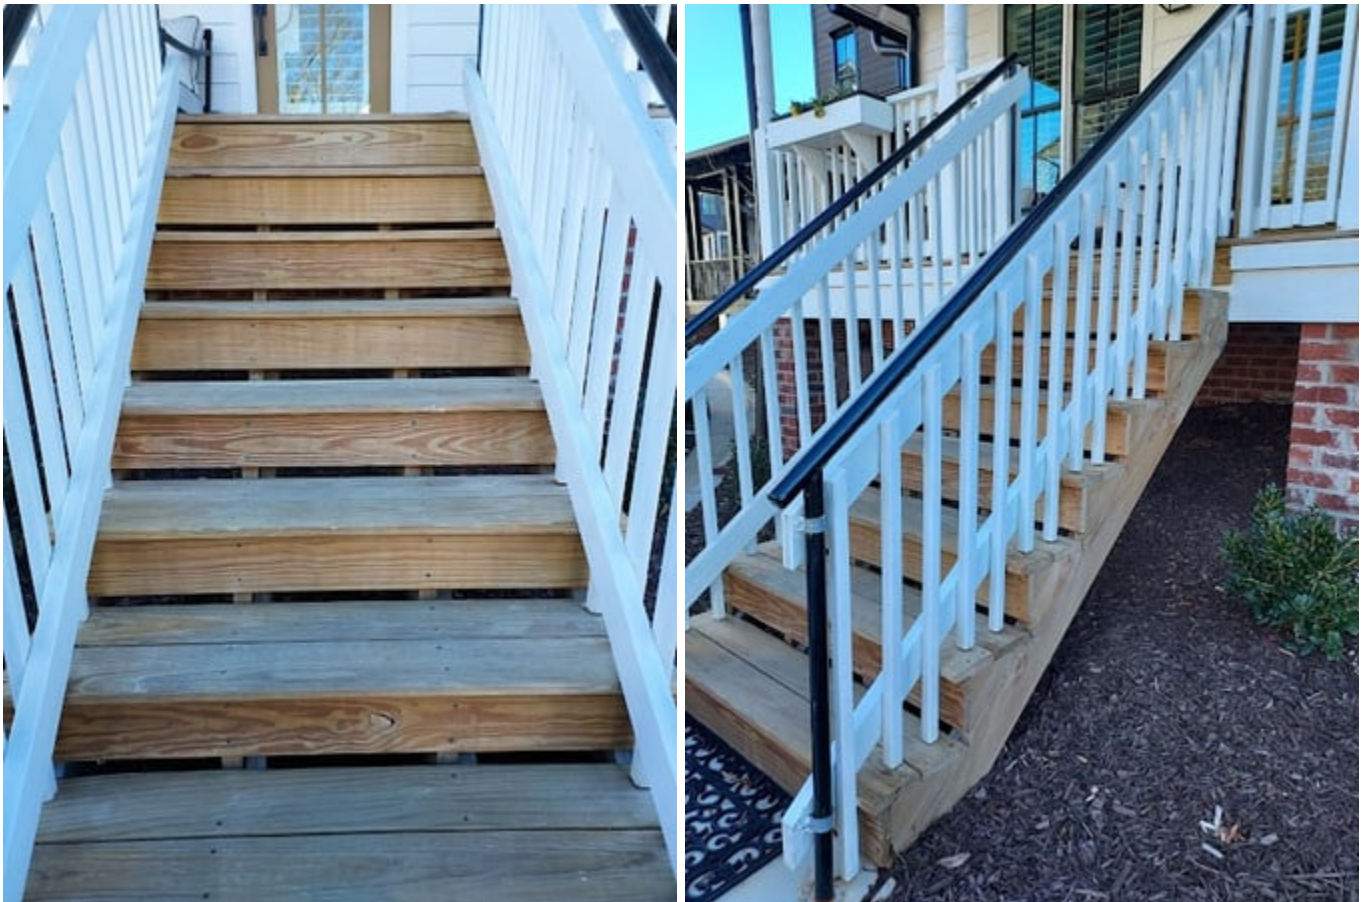
Stairs, Steps, Stoops, Stairways and Ramps

Stairs and stair treads in good shape. Recommend a form of non-slip strips be added to wooden treads to reduce the risk of slipping when treads get wet.

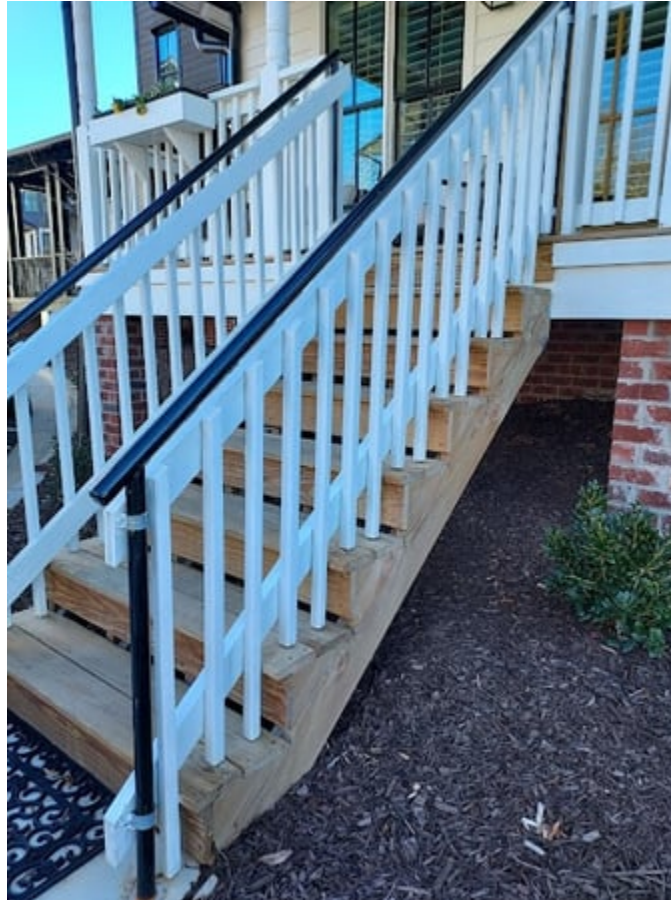
Railings, Guards and Handrails

Handrails are in good shape. No spacing issues with the balusters.

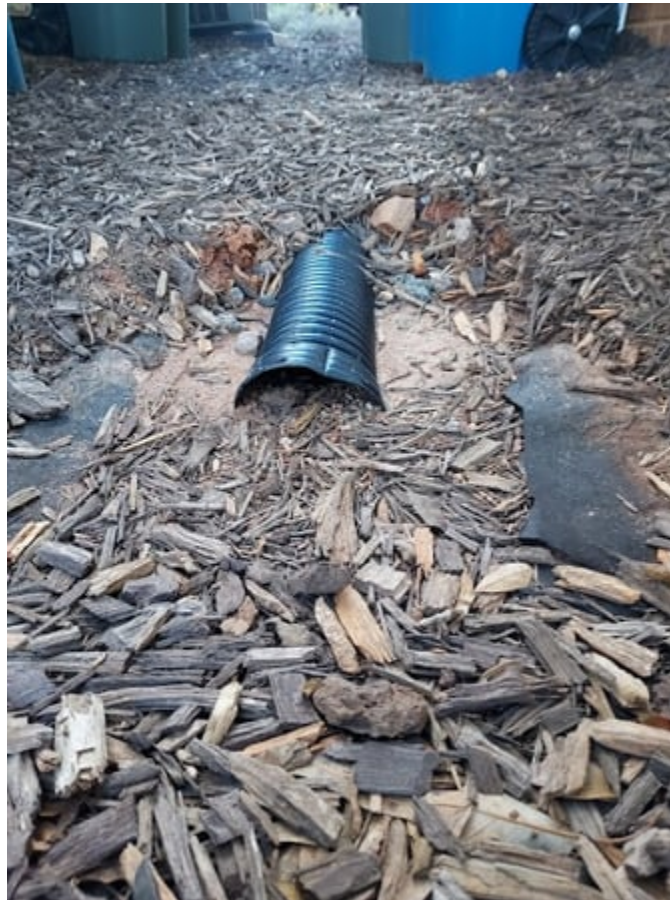
Vegetation, Surface Drainage, Retaining Walls and Grading of the Property (where they may adversely affect the structure due to moisture intrusion)

No major defects noted. I do want to mention the drain pipe shown in the picture. I could not tell where this pipe begins but the termination point is left open and almost clogged to the point of failure. Recommended that a professional service be called to assess and possibly repair.

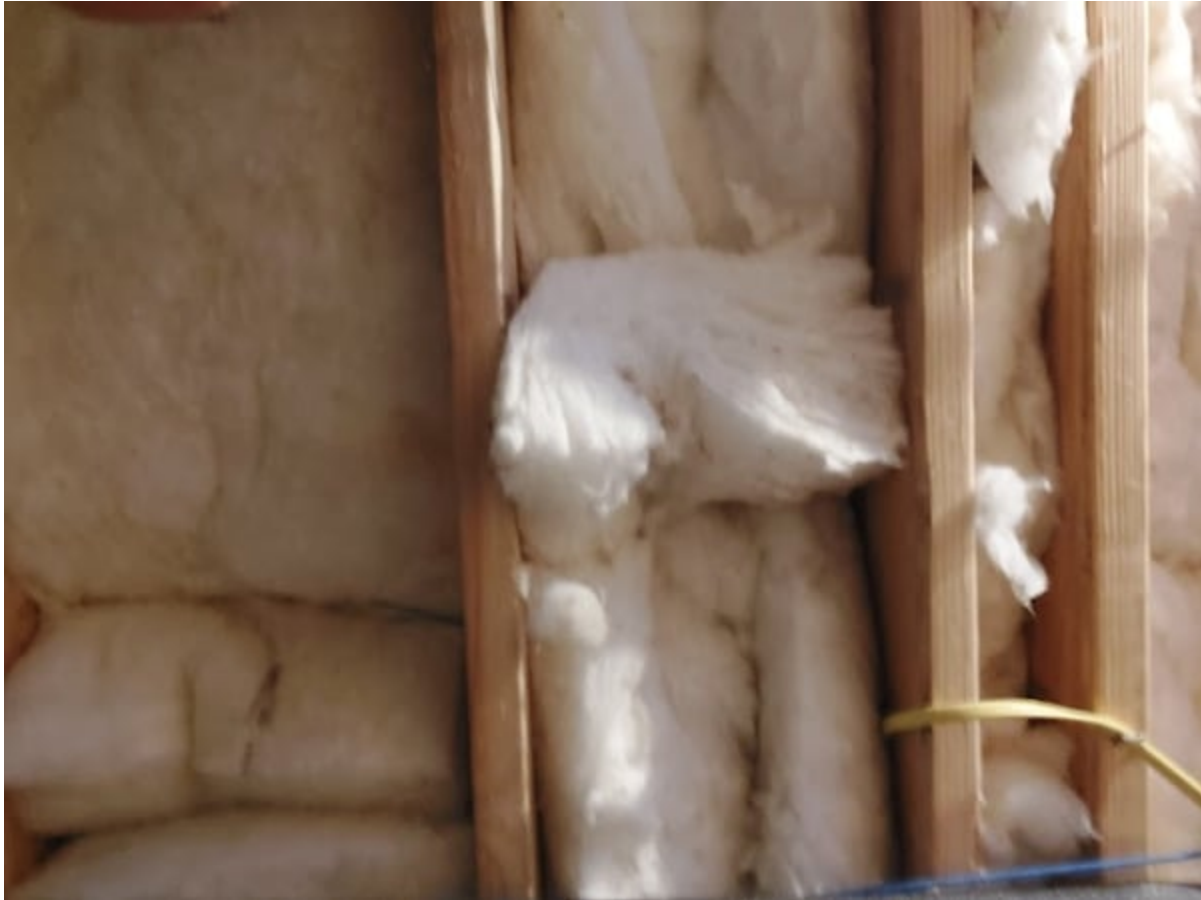
Structural Components

Structural components in good shape. Insulation installed.

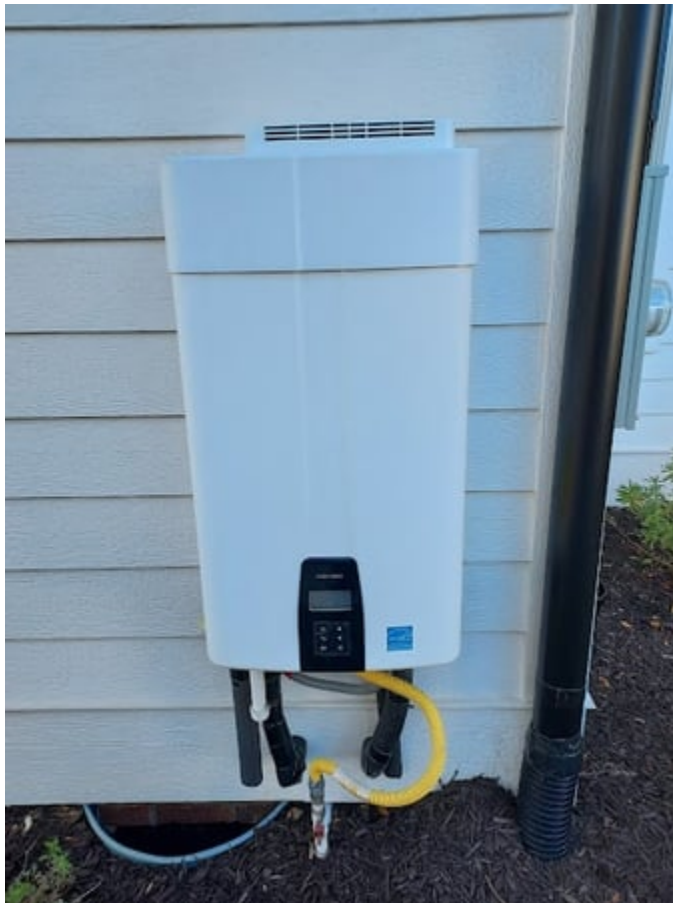
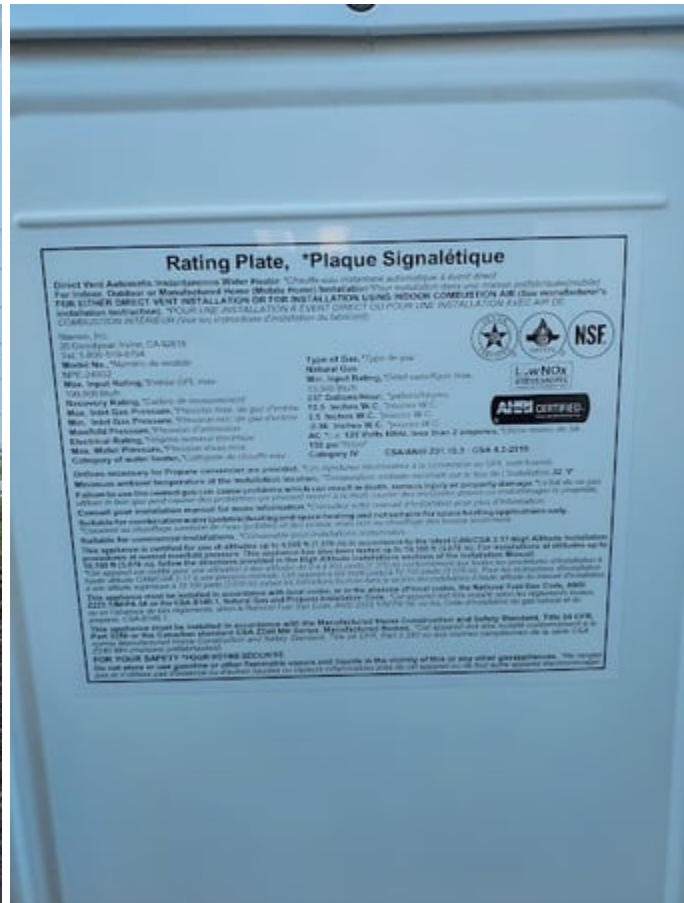
Water Heating Equipment (including the energy source, venting connections, temperature/pressure-relief (TPR) valves, Watts 210 valves, and seismic bracing)

Water heater is a direct vent automatic instantaneous water heater. The unit is mounted/installed outside to the exterior rear wall.
